## **ENGINEERING AUDIT REPORT – 10 ACRE FOOD FOREST PROJECT**

Date: 9th-11th April,2026

Project: Food Forest for Orphans

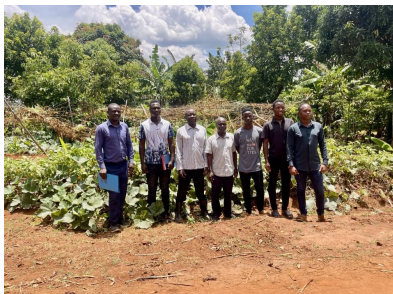
Basic perimeter fencing is not installed to protect crops from animals and unauthorized access.

Fencing should be strengthened to ensure durability and safety for children.
